SKETCH OF A GERMAN TANK CAPTURED ON APRIL 24th, SOUTH OF VILLERS-BRETTONNEUX.

Scale approx. 1/60.

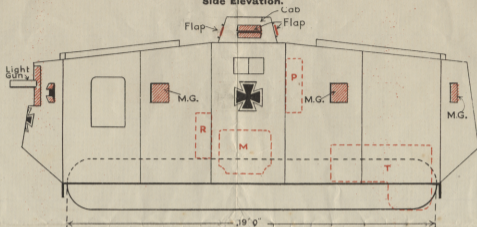
Side Elevation.

Points most vulnerable to Rifle and Machine Gun bullets shown hatched in red.
French A.P. bullets have penetrated the cab. Ordinary bullets pass through apertures if flap is open, and through space between Gun Shield and front of Tank.
The "splash" of ordinary bullets is effective against cab, and against Machine Gun emplacements. Armour Plate is of poor quality, and there is no protection against the "splash" of an ordinary bullet.
This Tank cannot cross a large trench (8 feet or over) or large shell holes.

A direct hit will put this Tank out of action. The most favourable moment for firing at the Tank is when in crossing an obstacle, it exposes its under-carriage. This is undoubtedly its most vulnerable part.

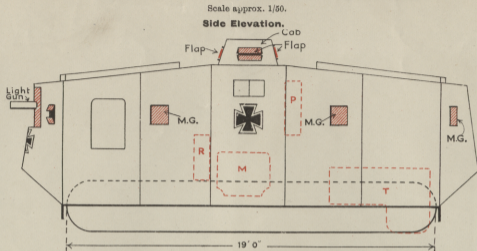
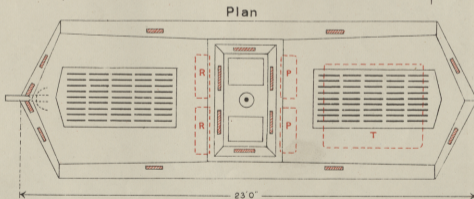
SKETCH OF A GERMAN TANK CAPTURED ON APRIL 24th, 3817
SOUTH OF VILLERS-BRETONNEUX.

Points most vulnerable to Rifle and Machine Gun bullets shown hatched in red. French A.P. bullets have penetrated the cab. Ordinary bullets pass through apertures if flap is open, and through space between Gun Shield and front of Tank. The "splash" of ordinary bullets is effective against cab, and against Machine Gun emplacements. Armour Plate is of poor quality, and there is no protection against the "splash" of an ordinary bullet. This Tank cannot cross a large trench (8 feet or over) or large shell holes.

A direct hit will put this Tank out of action. The most favourable moment for firing at the Tank is when in crossing an obstacle, it exposes its under-carriage. This is undoubtedly its most vulnerable part.

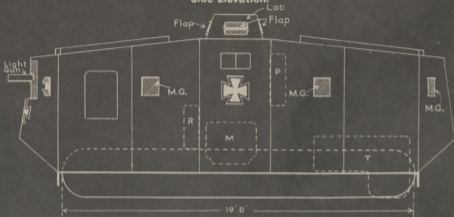
Side Elevation.

Points most vulnerable to Rifle and Machine Gun bullets shown hatched in red.
 French A.P. bullets have penetrated the cab. Ordinary bullets pass through apertures if flap is open, and through space between Gun Shield and front of Tank.
 The "splash" of ordinary bullets is effective against cab, and against Machine Gun emplacements. Armour Plate is of poor quality, and there is no protection against the "splash" of an ordinary bullet.
 This Tank cannot cross a large trench (8 feet or over) or large shell holes.

A direct hit will put this Tank out of action. The most favourable moment for firing at the Tank is when in crossing an obstacle, it exposes its under-carriage. This is undoubtedly its most vulnerable part.
 Above Drawings are made from direct measurements of an actual Tank and from Photographs of same.
